Manhole Inspection Summary

Manhole # S13AA1028MH

Location Address: **3919 WABASH AVE**

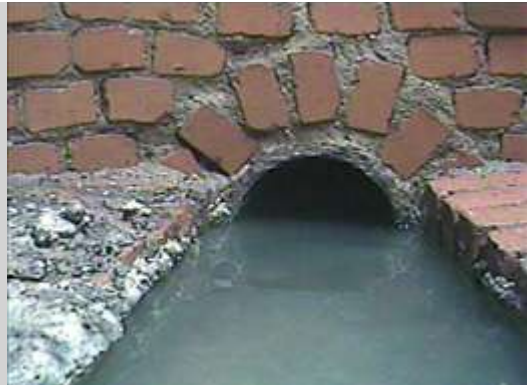
6 O'Clock Inflow

10 in. Circular Gravity Sewer

Pipe In @ 6 O'Clock

Pipe Material: **Clay** ☐ Pipe Lined

Invert Depth: **12.32** (ft.) Flow Characteristics: **Slow**

Deposits: ☒ None ☐ Mud ☐ Sludge ☐ Debris ☐ Grease

Infiltration: **None** Pipe Seal Cond: **Sound**

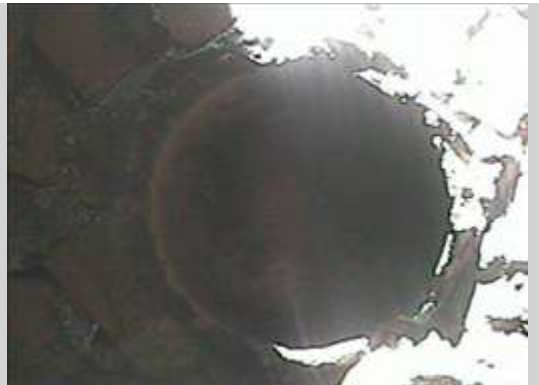
9 O'Clock Inflow

10 in. Circular Gravity Sewer

Pipe In @ 9 O'Clock

Pipe Material: **Clay** ☐ Pipe Lined

Invert Depth: **9.42** (ft.) Flow Characteristics: **Turbulent**

Deposits: ☒ None ☐ Mud ☐ Sludge ☐ Debris ☐ Grease

Infiltration: **None** Pipe Seal Cond: **Sound**

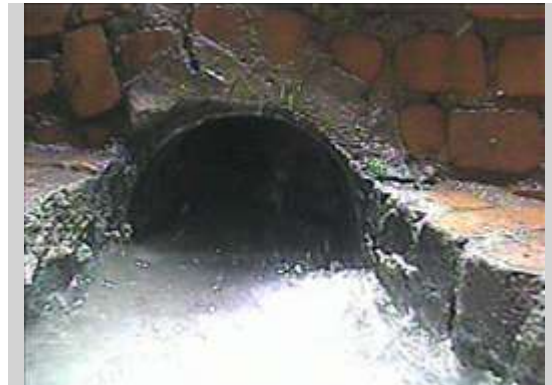
Drop In @ 9 O'Clock

Drop: **Outside Direct**

Drop Condition: **Open**
